## OUTLINE OF REPAIRS

OUTLINE OF REPAIRSTABLE OF CONTENT

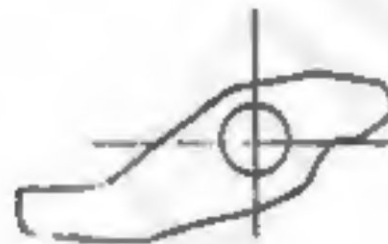
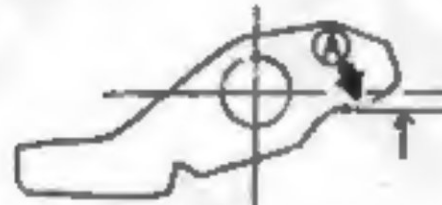
### 1) Improper selection of CA8844 (Lever)

8844 is available in following 3 types. Adjustment should be made on the timing of brake release by replacement of 8844 with a proper type.

Some of 8844 are bent for adjustment of engagement between 8828 (Shaft) and 8833 (Plate). This should be checked at the time of replacement.

If, even upon replacement with 8844C, the film advance motion is not smooth yet, the portion marked A may be slightly hammered out. (Do not work excessively, as it will cause the spring to be readily pressed from the beginning of the motion.)

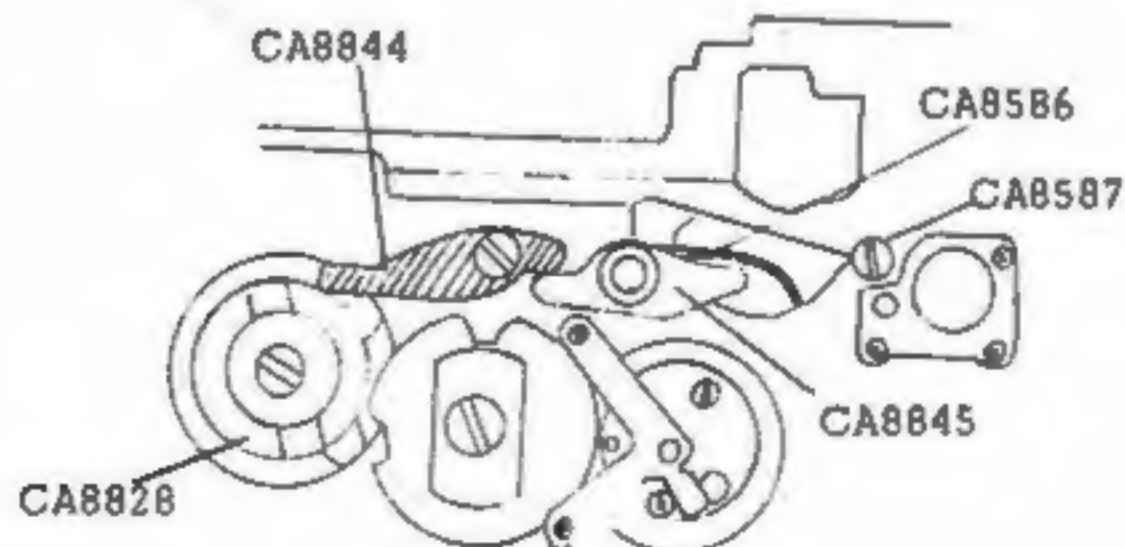
## 2) Adjustment required of brake force

Strengthen the force of 8586 (Spring) with 8587 (Eccentric screw).  
After this adjustment, be sure to check the bouncing effect.

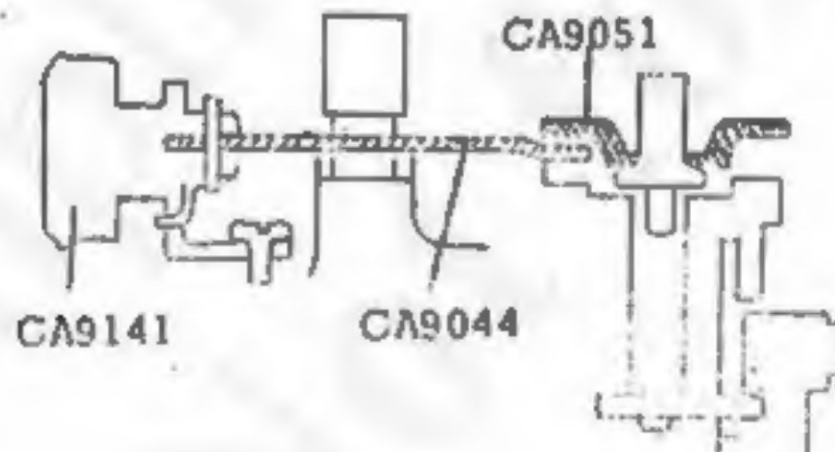
### 2) CA9051 (Plate) stuck with CA9044 (Plate)

When 9051 is extremely deformed, replacement is required. Clean the sliding portion of both 9051 and 9044, and apply small amount of Molicote (Grease) Type U.

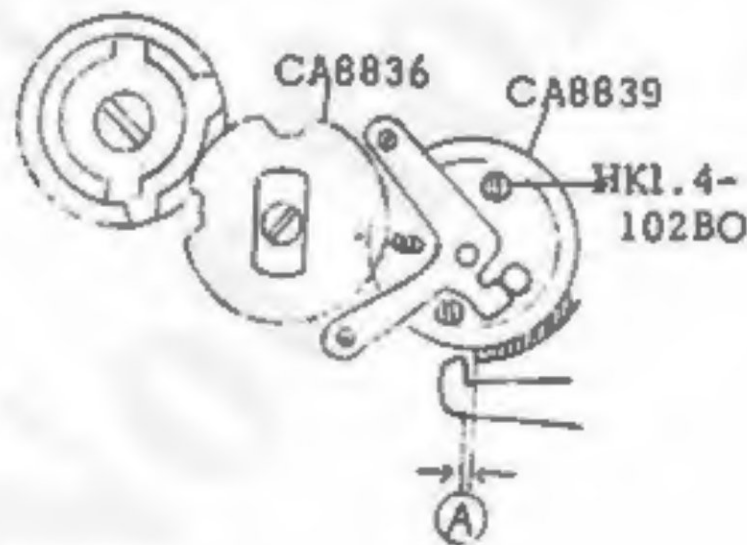
- (2) If insufficient engagement is found in the vertical direction,
  - o Bend 8592 and adjust
  - o Adjust tolerance on 8592
  - o Replace 8592
  - o Replace the Gear A (the whole assembly of 8543)
4. Excessive or insufficient film advancement for Shutter-Charging
  - 1) Improper adjustment of Eccentric Screw (8809)

In case of insufficient film advancement, loosen two HK1.4-102BO to widen the distance at A by adjusting (8809).

In case of excessive film advancement, narrow the distance at A by adjustment of (8809).

Care must be taken not to make an over adjustment causing the mechanism unchargeable.

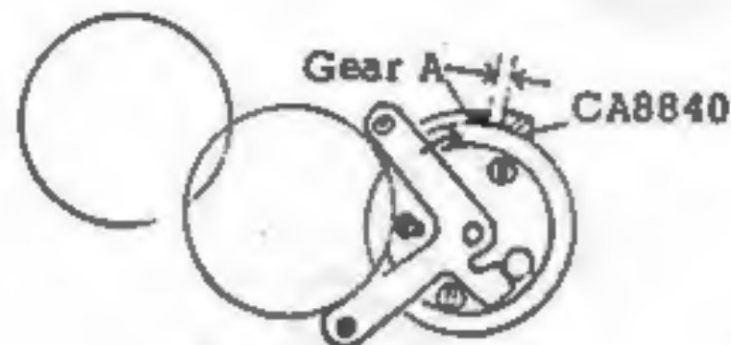
Prior to film advancement, when the Gear A is pressed in the arrowed direction, the distance between 8840 and the Gear A should be  $-0.10 \sim +0.3$ . ( $-0.10$  means the state where the Gear A comes in contact with 8840 and further moves by 0.1.)

Adjustment is similarly made by (8809).

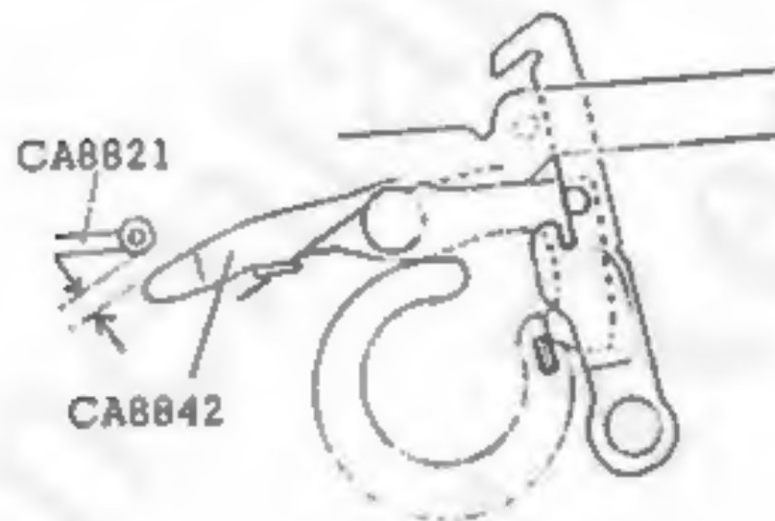
## 5. Locking device for the Film-advancing not operating properly

### 1) Improper operation of related parts

- (1) If the shutter cannot be released upon film advancement, check if 8842 (Lever) and the Stopper Ring of 8821 (Lever) are in contact with each other. They should not.

Refer to the following checkup column, and check the operation of related parts.

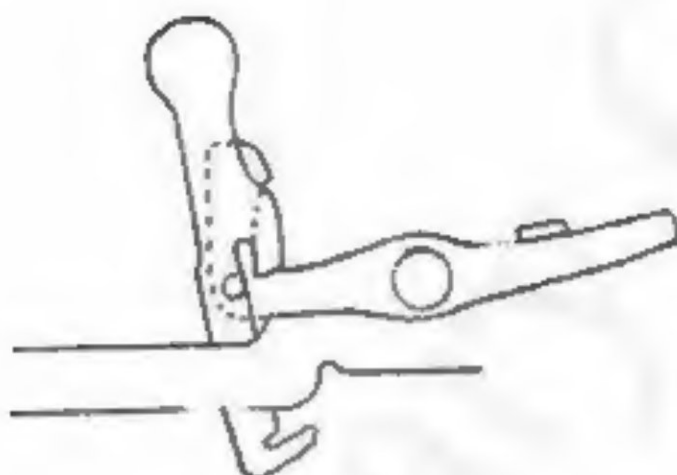
## 6. The shutter can be released during or prior to film advancement.

### 1) Improper operation of related parts

Check the operation of related parts. If the shutter cannot be released even upon film advancement, make sure 8850 (Pin) is not hitting 8810 (Plate).

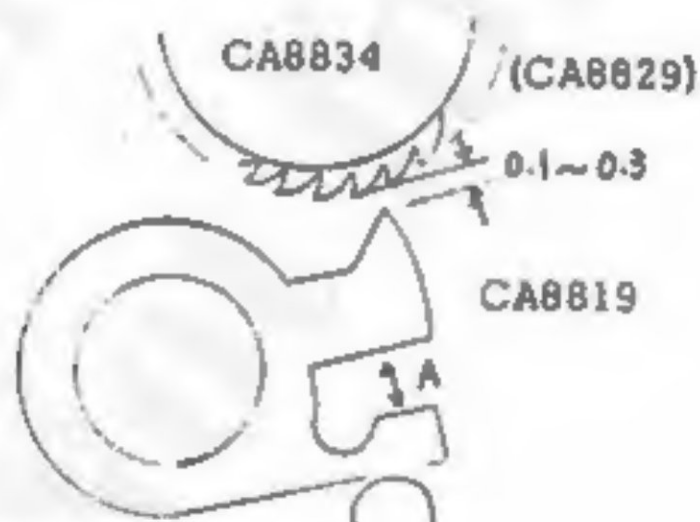
## 7. Shutter cannot be charged.

- 1) Improper operation and/or adjustment of CA8819 (Claw)

Refer to the checkup column. Adjust the distance A on 8819.

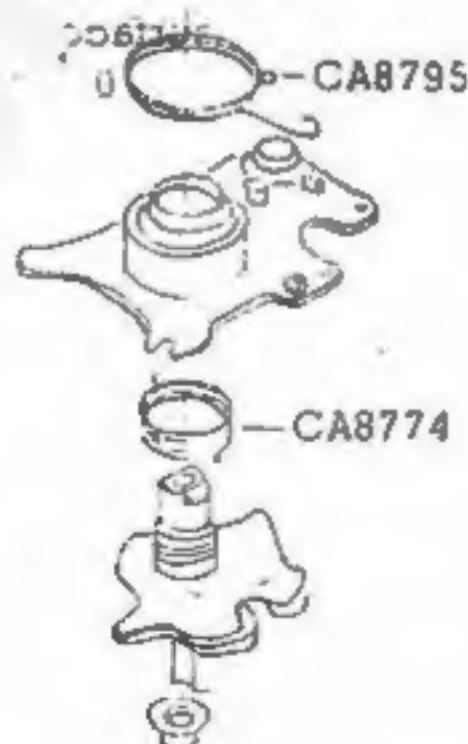
9. CA8749 (Lever) does not return completely and/or smoothly to the original position.

- 1) Top-cover mounted slightly off position.

When 8703 (Top-cover) is mounted off position, it will cause 8753 (Decoration) and 9083 (Washer) to rub each other.

- 2) CA8774 (Spring) and CA8795 (Spring) worn out, broken or entangled.

The position of the 8703 should be adjusted.

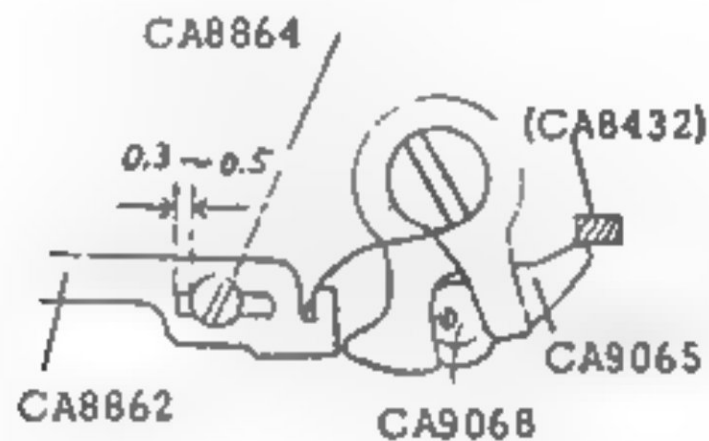
10. The shutter releasing position of the button too deep or too shallow.  
Excessive or insufficient leeway in the button motion after the shutter release.

1) Improper adjustment of CA9068 (Collar).

9068 should be adjusted so that the mirror commences its operation when the distance between the oblong hole of 8862 and 8864 at their edges is  $0.3 \sim 0.5$ .

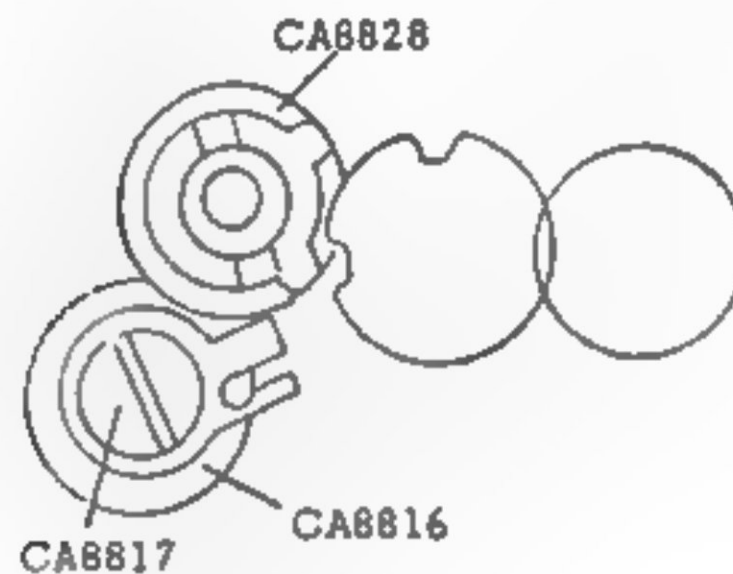
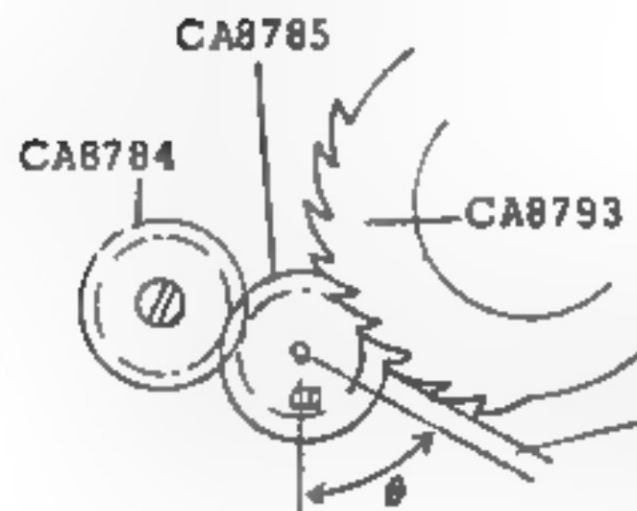
## 12. Uneven intervals between picture frames.

### 1) Improper positioning of Sprocket Teeth

After the film is advanced and locked, bring 8785 (Gear) to rise within the range  $\phi$ , and make following adjustments:

Loosen 8817 (Screw) and change the position of engagement between 8816 (Gear) and 8834 (Gear).

The Sprocket will turn 1.66mm more, or less, when the engagement is changed by a tooth on 8816 (Gear).  $\rightarrow$  (The lowest gear is 8834.)

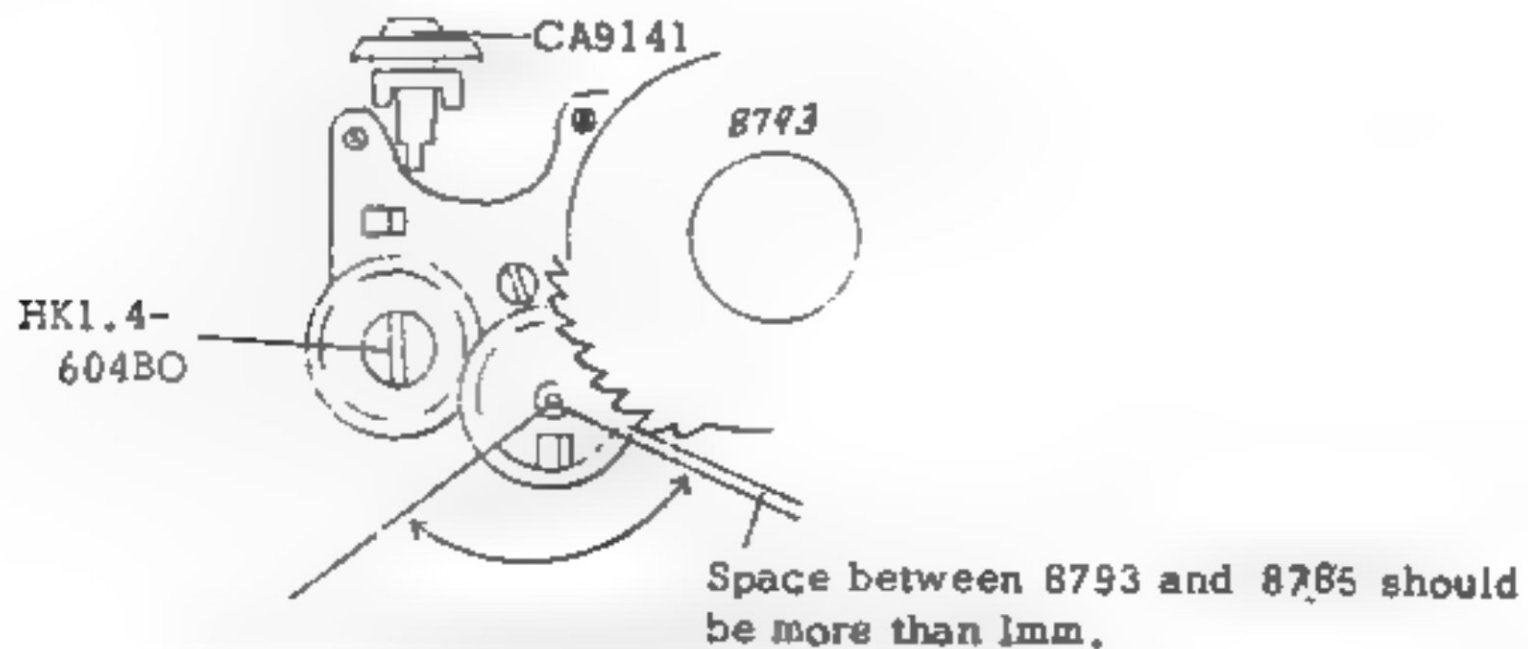
### 13. Film Counter Plate not moving properly.

#### 1) Improper positioning of CA8785 (Gear).

Set 9141 and loosen HK7.4-604 BO on 8784 to let it rise and adjust 8785 position. Upon completion of film advancement, 8785 should be positioned as follows (within the range shown by arrows.)

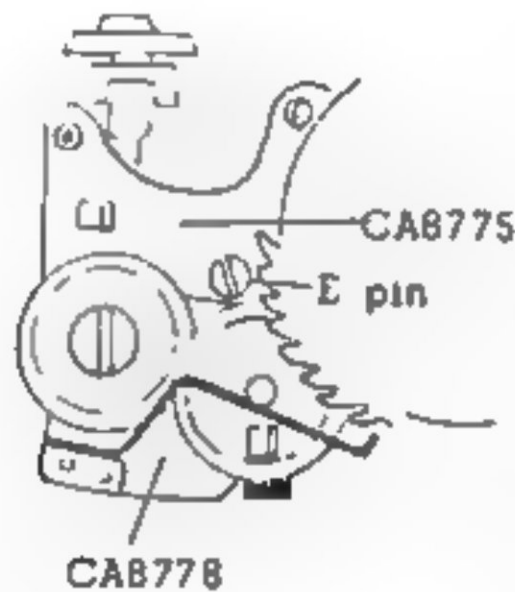
2) Improper positioning of CA8778 (Lever)

Keeping the E pin of 8775 at the neutral position of its eccentric motion, bend the Plate (A) so that 8778 will hit the E pin when the Rear Cover is closed.

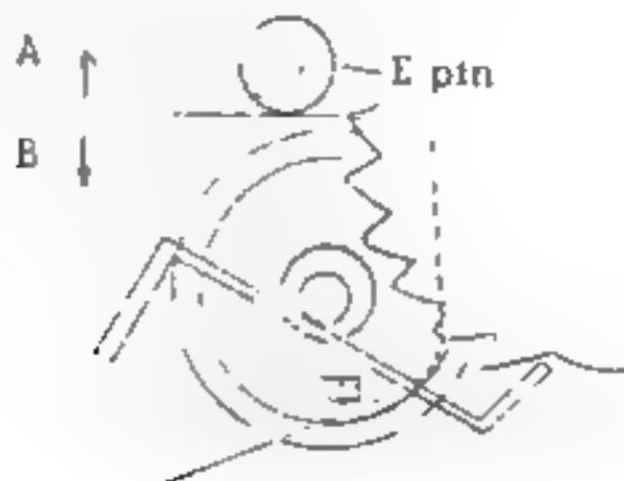
4) Improper position of CA8790 (Stopper)

When the Rear Cover is closed, the tip of (8790) should hit the bottom of the teeth of (8793). If it does not, an adjustment should be made by bending (8790) at the S position. Some room may be permissible between (8787) and (8790).

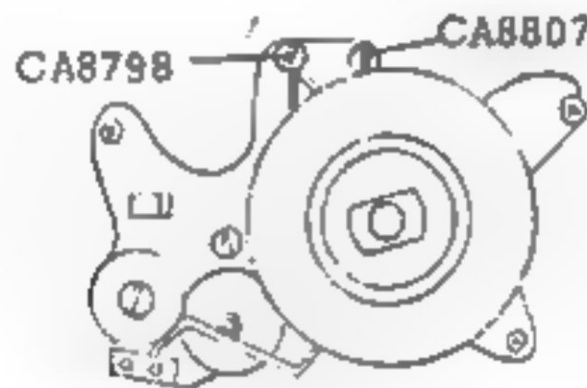
14. S point of the Film Counter Plate out of position.

1) Adjustment of CA8807 (Pin)

Loosen 8798 and adjust eccentricity of 8807 so that the tip of (8790) touches the bottom of the first tooth of 8793.

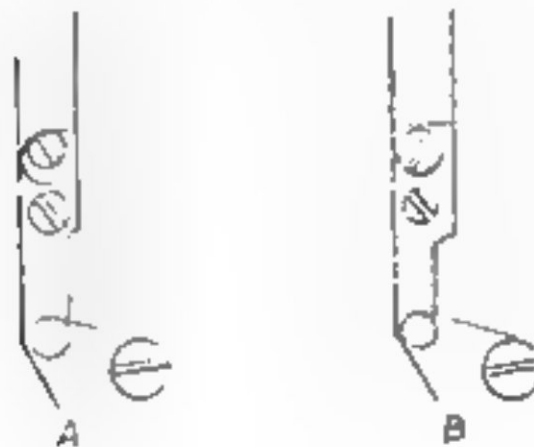
15. Little leeway stroke after the shutter release by the self-timer.

1) Adjustment of CA9089 (Screw)

A : Bigger leeway stroke after the shutter release and shorter self-timer operation.

B : Little stroke after the shutter release and longer self-timer operation.

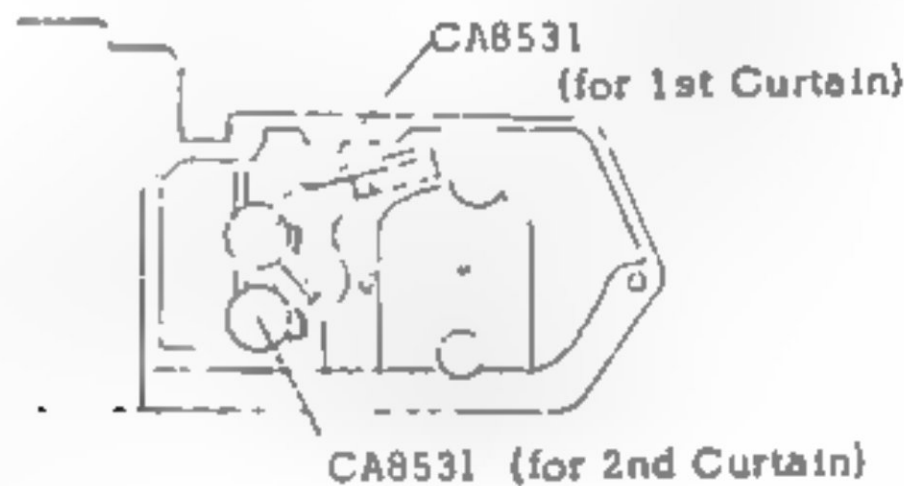
#### 1) Improper adjustment of CA8531 (Nut)

Turn 8531 to the left to increase the tension and thus speed up the curtain run.

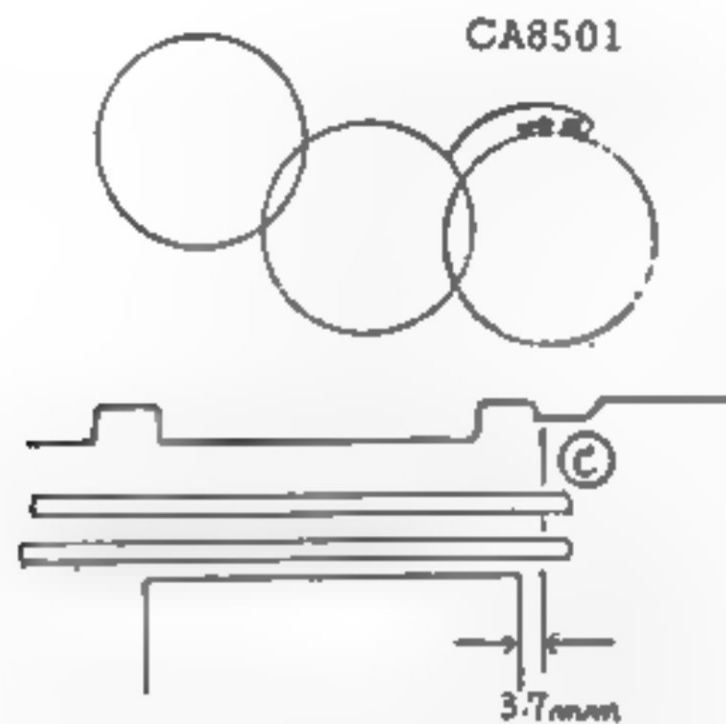
2) 1st curtain stops at the improper position.

If it does not, an adjustment may be made by moving vertically the mounting position of 8517 (Stopper) assembled in 8519 (Shaft).

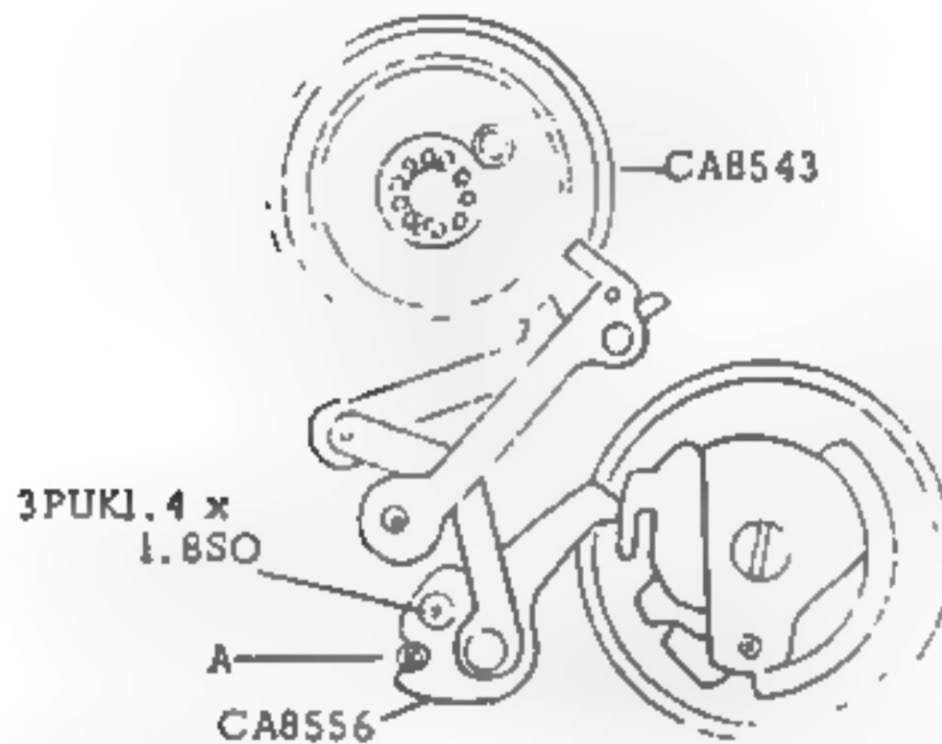
## 5. Improper timing at high shutter speeds:

If the speed at  $1/1000 - 1/60$  sec. is in average longer (or shorter) than the proper timing, and adjustment is to be made with A of 8556 (Lever).

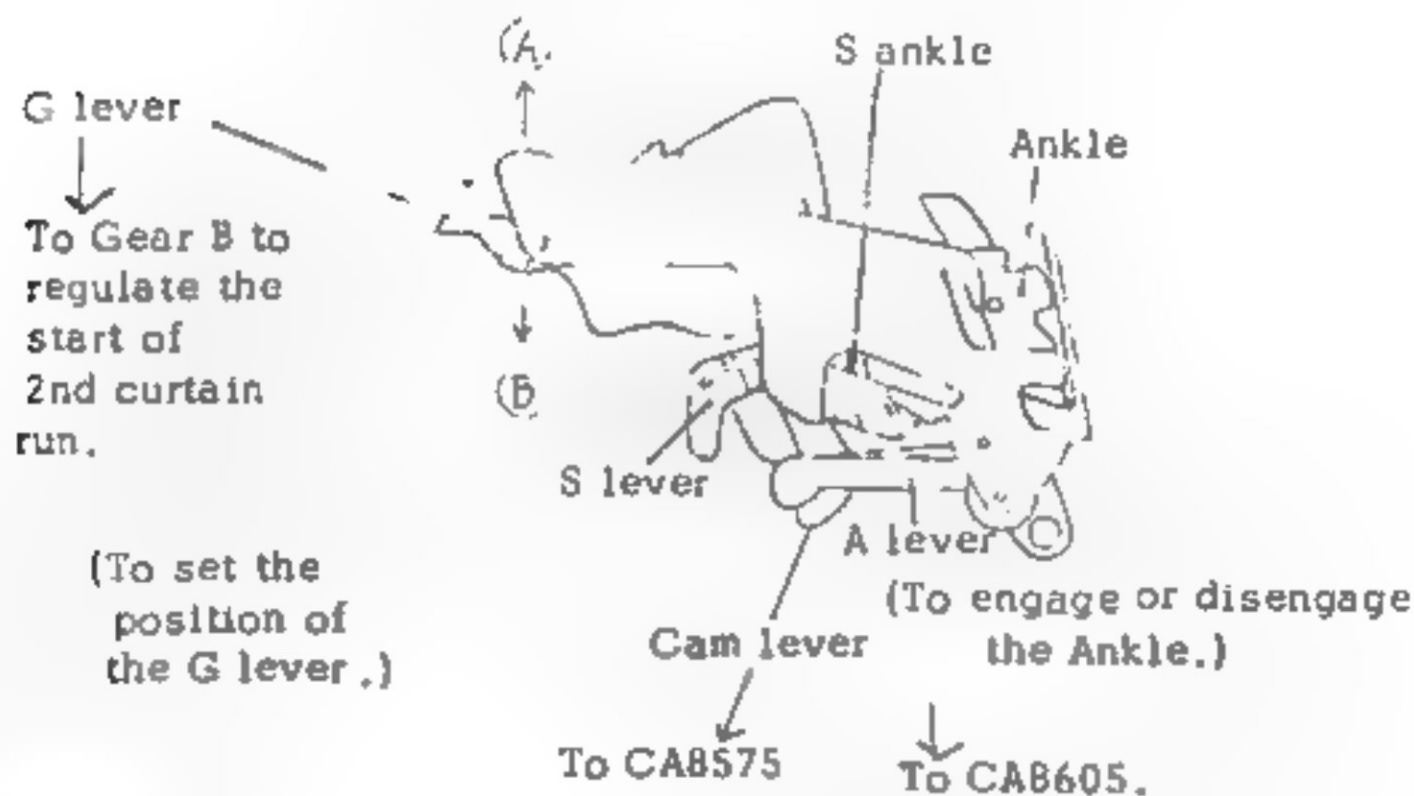
## 6. Improper timing at low shutter speeds:

If the speed at 1/30 - 1/1 sec. is in average longer (or shorter) than the proper timing, an adjustment is made by moving the governor. When it is longer, the governor is to be positioned rather towards the direction A, and when shorter towards B.

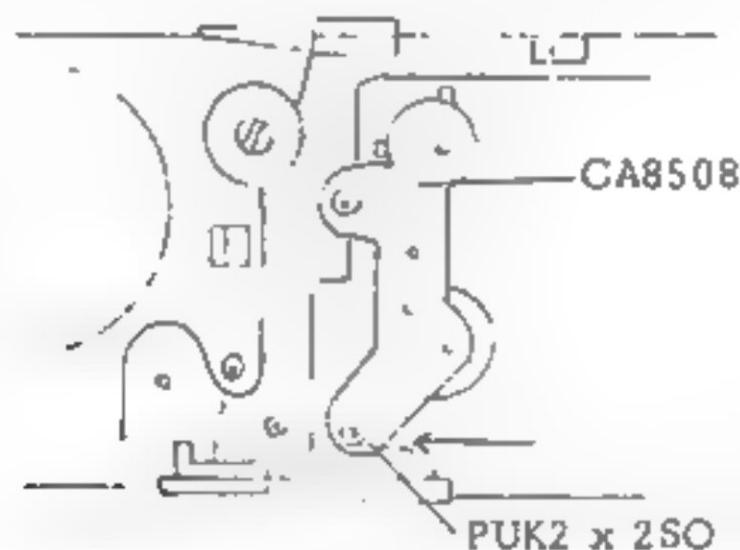
In case where the Shaft rattles vertically due to deformation of 8508, insert a U washer (0.1 - 0.2) underneath the Plate R on the arrowed side.

Loosen two PUK2 x 2SO of 8508 and adjust the position of 8508. Check for inclination of 8519 and 8520 and make necessary adjustment.
