Optimo Shutter Repair

by Michael Roth

The Optimo shutter is a pneumatic shutter designed by Wollensak in 1909 and was sold until about 1930. In Europe it was sold as the Velosto shutter. It is a high-end shutter with speeds from 1/300 to 1 second plus B and T. For a while it was the fastest leaf shutter on the market, even faster than the famous Compound and Compur shutters at that time.

This particular shutter had a faulty diaphragm blade. I found the helpful booklet “Photographic Inter-Lens Shutters” from 1917 on the web to get started. Fixing the diaphragm blade requires a complete disassembly of the shutter. The following pictures show a step-by-step disassembly and can be used in reverse to put it all together again. Make sure you arrange all the parts in the order of disassembly so it is easier to find the right parts during reassembly.

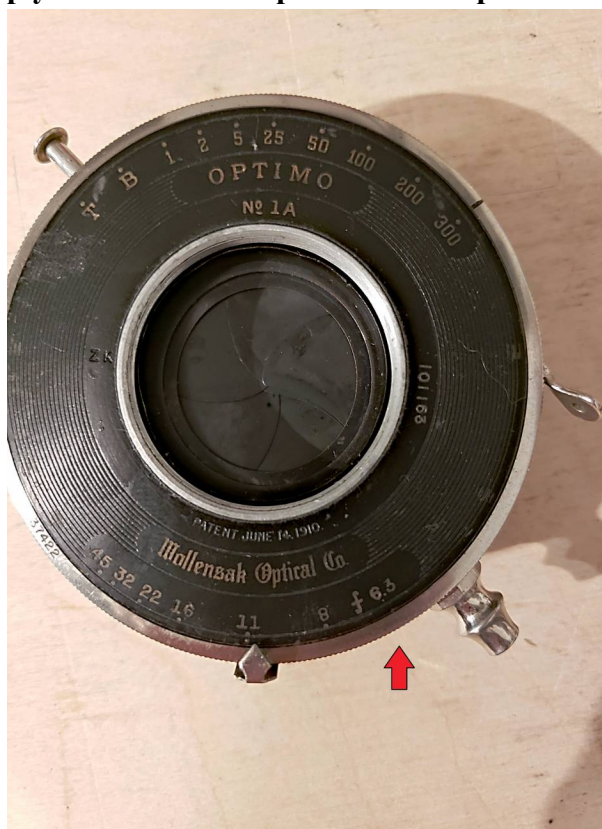
Step 1:

The first challenge is taking off the faceplate since there are no screws involved. To do this locate a little lever at the right end of the slot for the aperture lever (see red arrow and next picture).

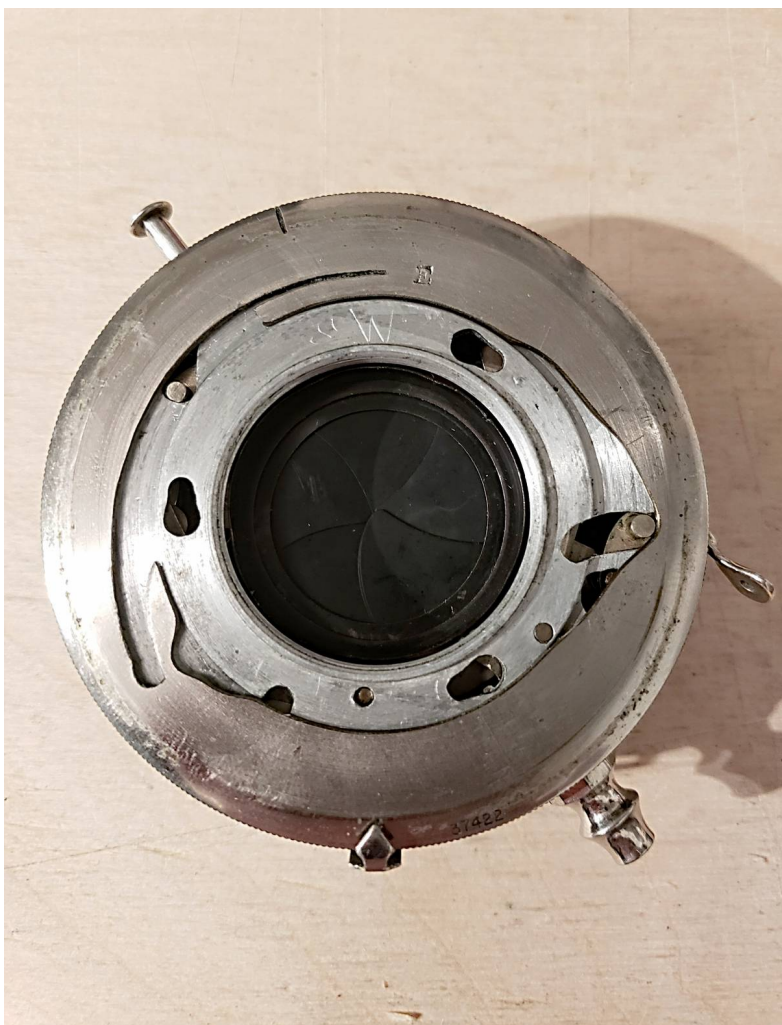
Step 2:

The red arrow points to where the lever is. The lever needs to be pushed to the right. A small micro screwdriver works well for this. Then a little twist and the faceplate comes off.

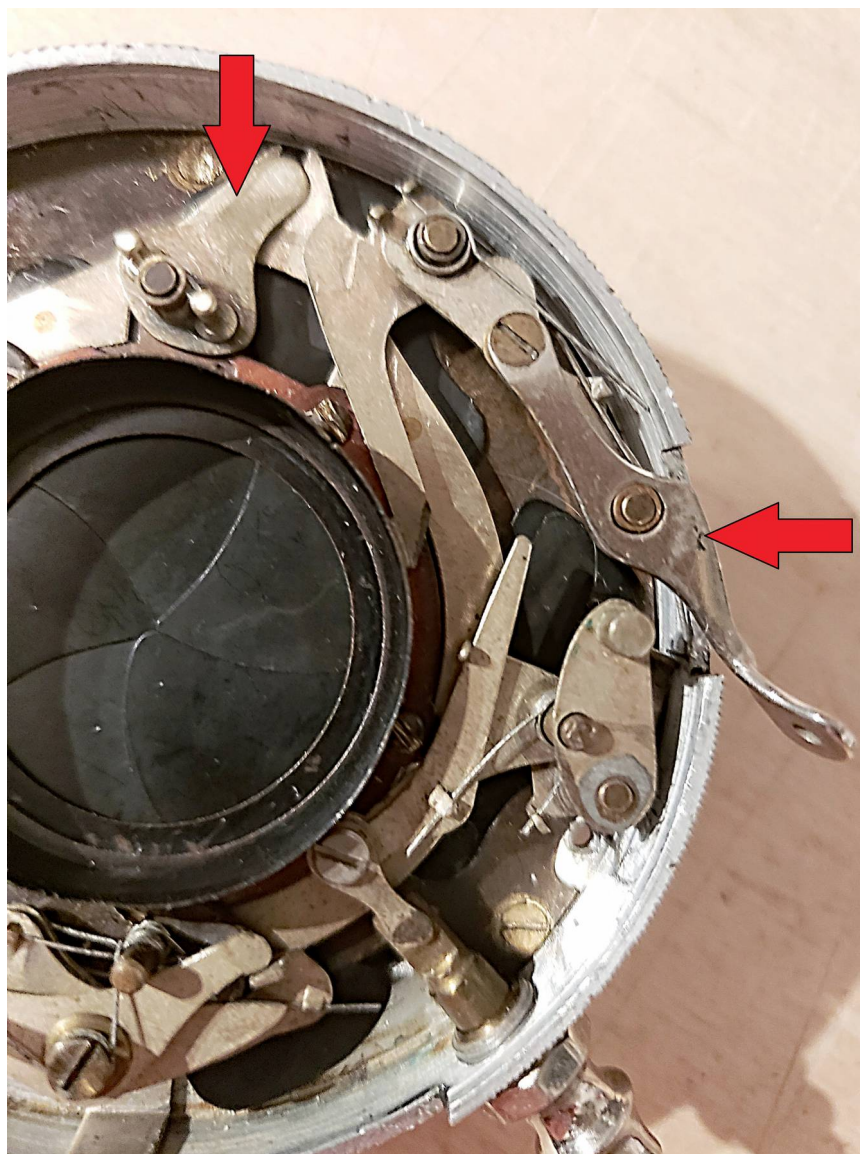
Step 7:

This assembly indicated by the arrow and the associated spring come off – this is a large spring that has quite a bit of tension!

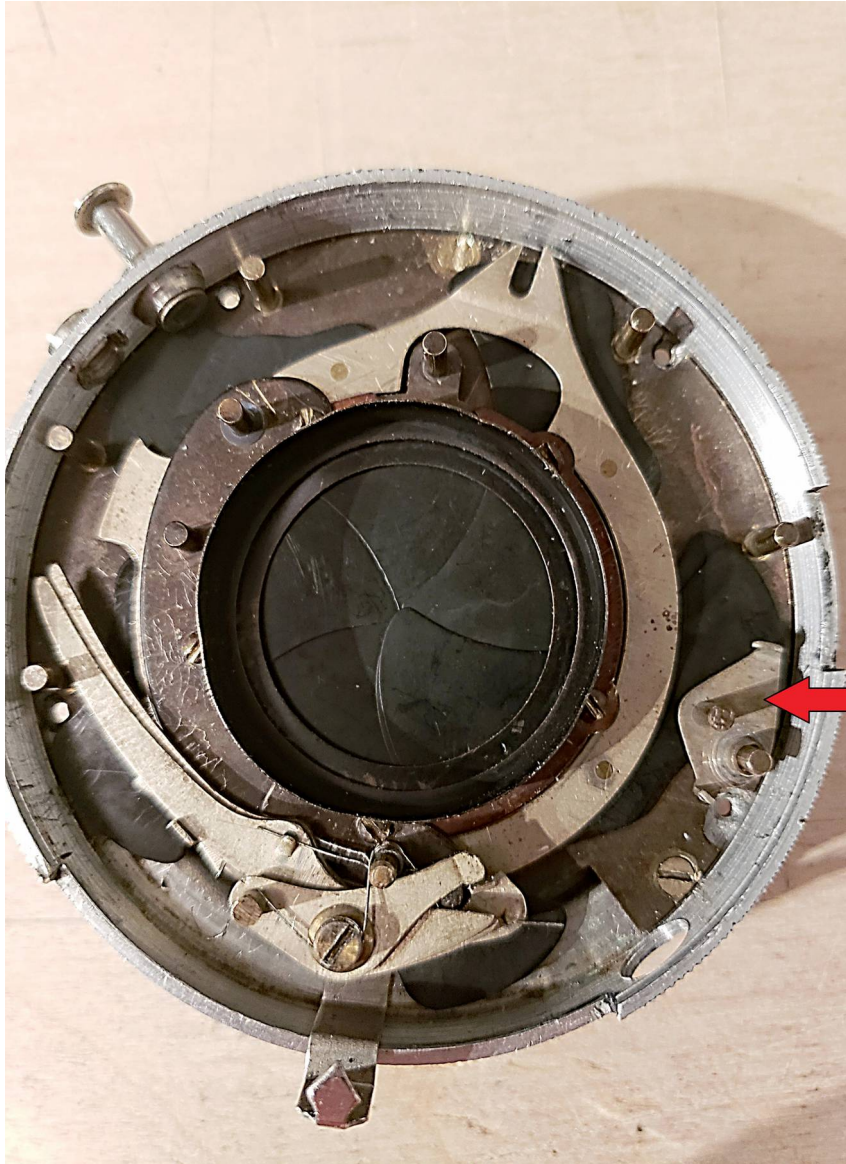
Step 10:

Now remove the parts and associated springs as indicated. This picture will be an important reference for the location of the springs during reassembly!

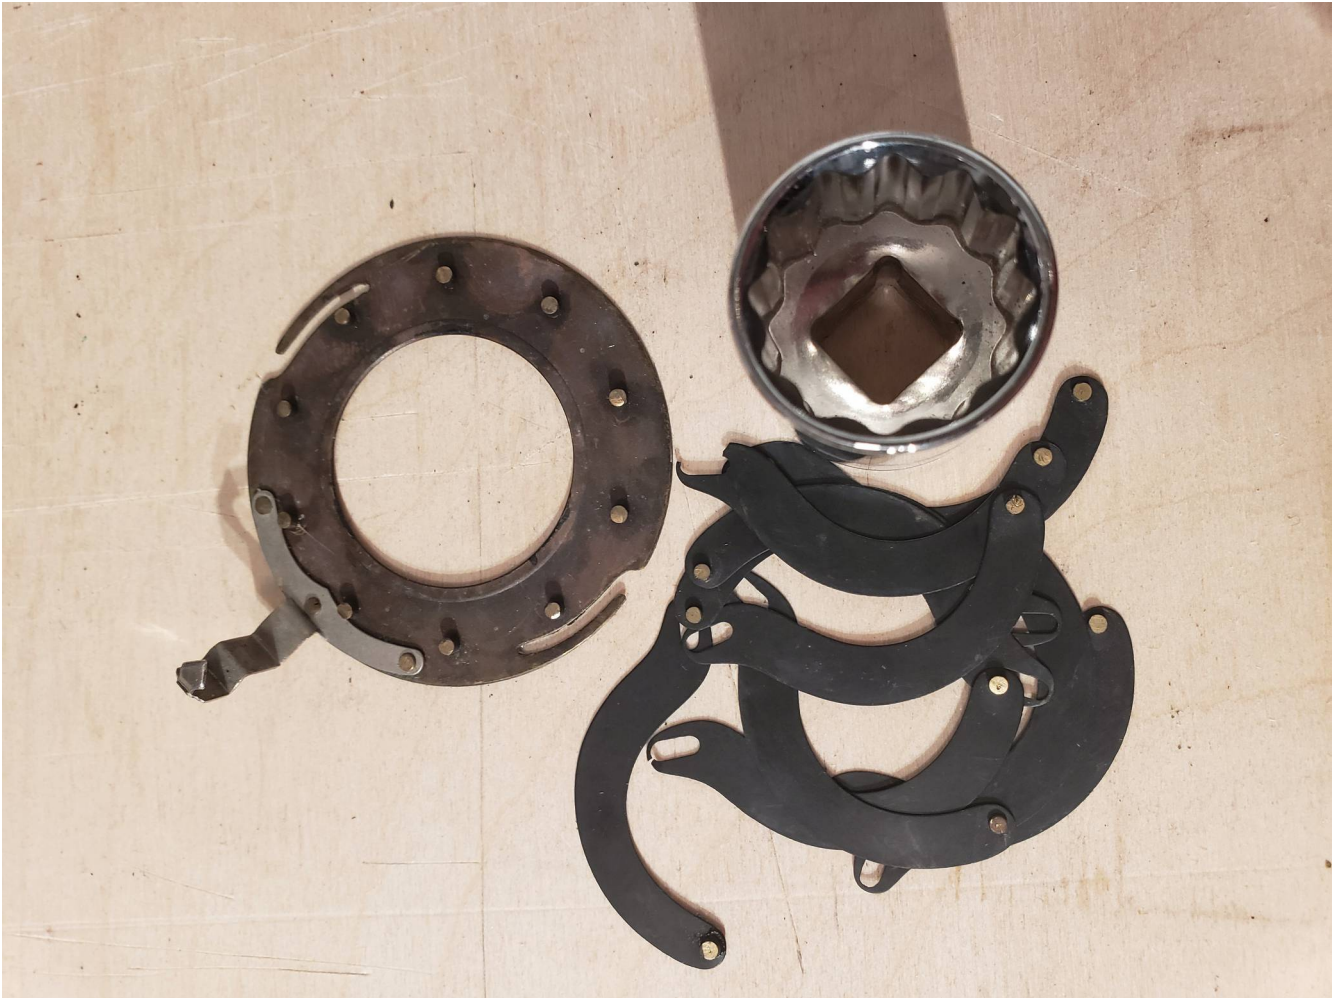
Step 19:

This is how a set of nicely assembled diaphragm blades looks like before the base plate is installed.

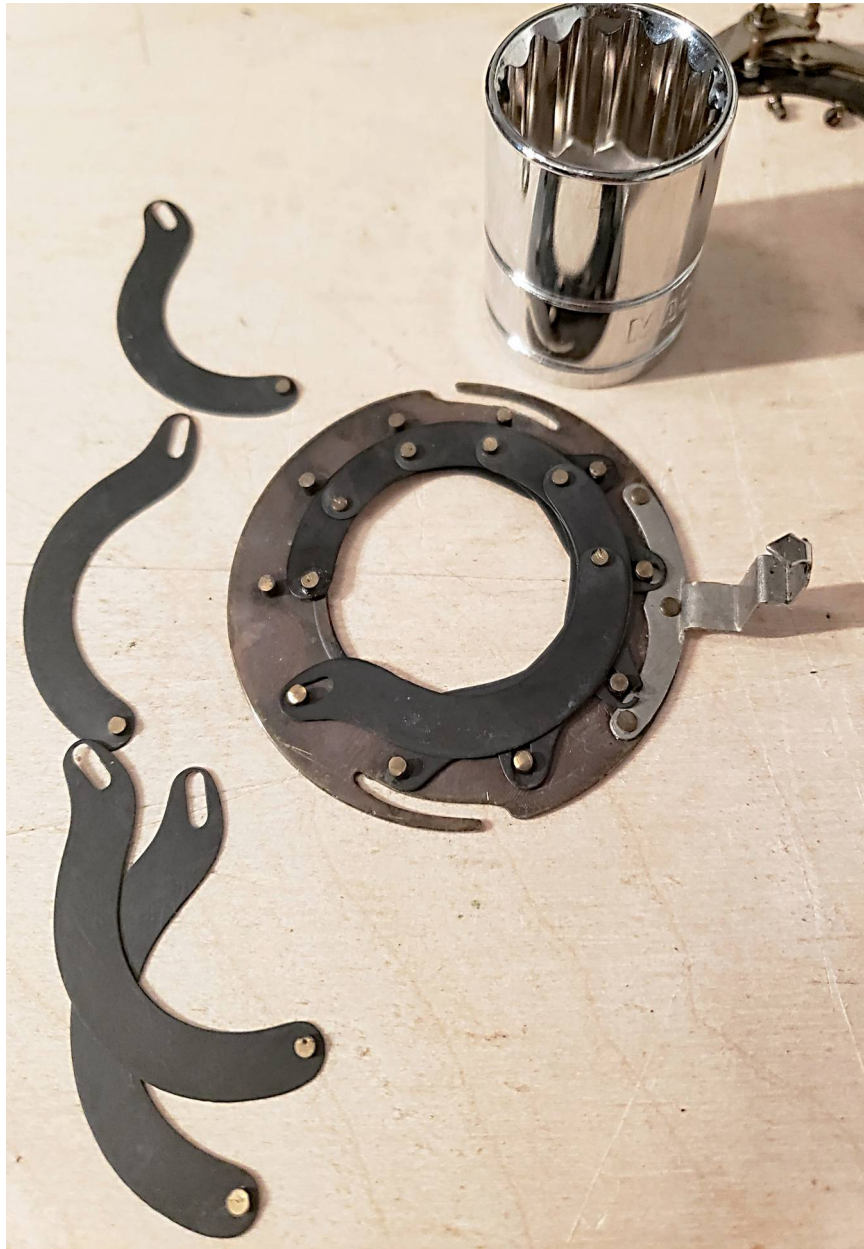
Step 20:

Here are all the diaphragm blades before reassembly. Some blades are damaged on the side with the opening, opposite of the end with the brass piece. Interestingly this doesn't seem to affect the operation. Before reassembling the diaphragm blades you need a round tube that fits in the inner circle – a socket is perfect for the job.

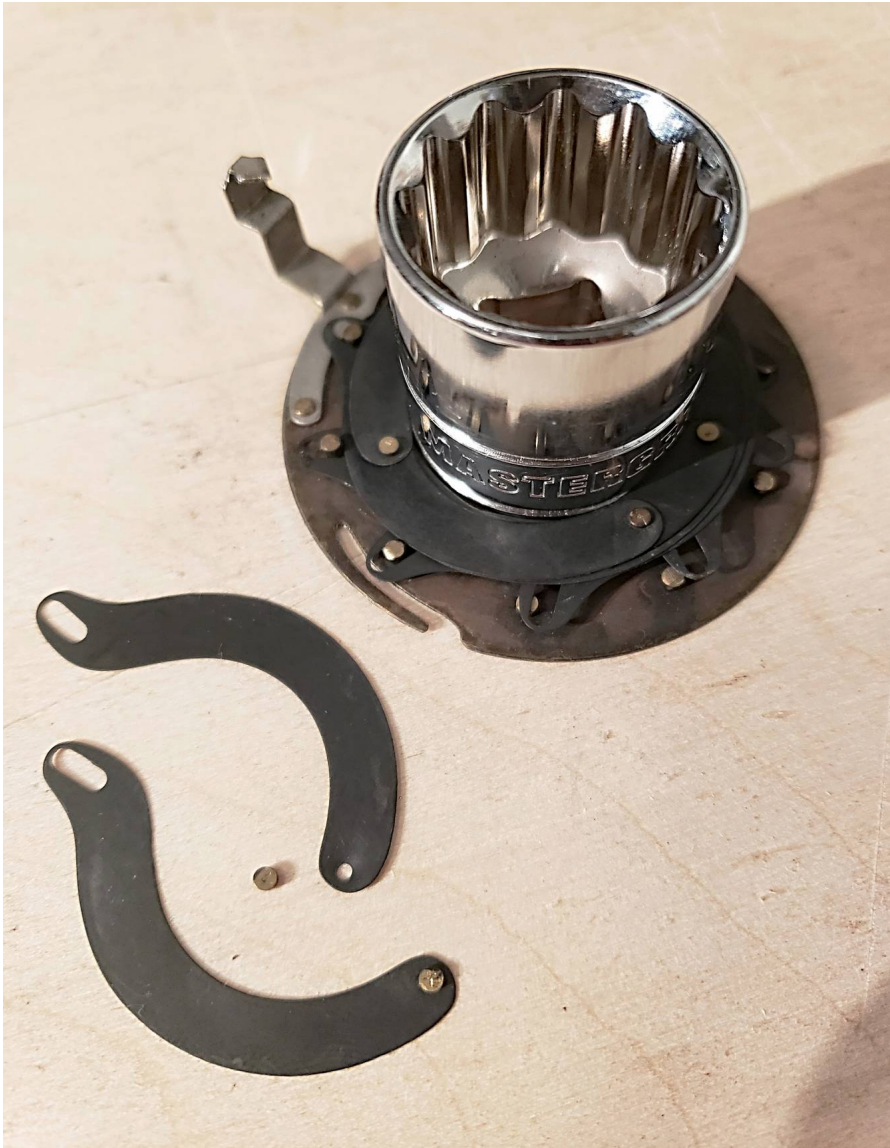
Step 21:

The first 6 diaphragm blades can easily be stacked in sequence on top of each other as shown. The next four blades are more tricky. The tube / socket needs to be placed in the middle to help keep the blades in place while carefully inserting the other four blades.

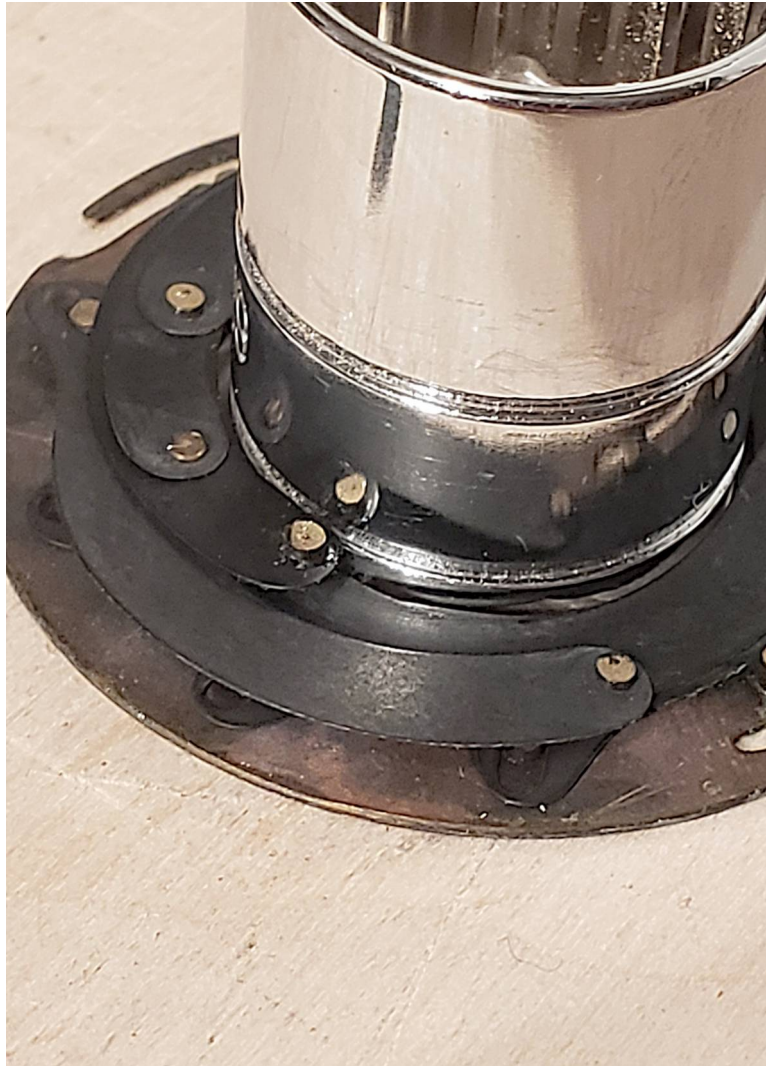
Step 22:

Inserting the remaining blades is a delicate job, but the shape of the blades for the Optimo shutter make it an easier job than for other shutters I have worked on. This would be much more difficult without the socket placed in the middle. Here you can also see the defect diaphragm blade where the little brass button had broken off. I fixed it with some cloth tape in the back of the hole and super glue. Obviously replacing the blade would have been ideal but that was not an option. Going forward this blade is going to be the archilles heel of the shutter, but so far it has been operating normally.
