## OUTLINE OF REPAIRS

OUTLINE OF REPAIRSTABLE OF CONTENT

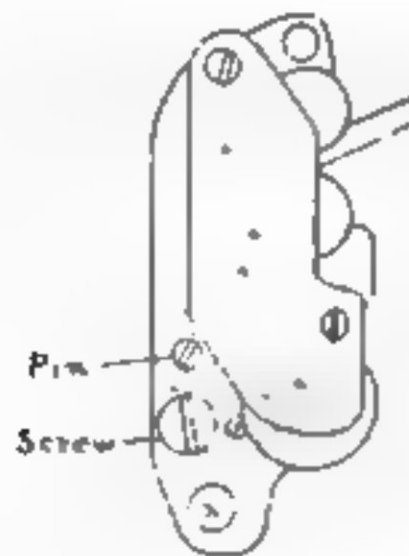
- 1) S stopper pin of the self-timer not properly adjusted.

The slant at the tip of the ST lever should be 0.3mm or less.

Loosen the screw and adjust the S stopper pin (eccentric).  
After adjustment, tighten the screw fully and bond it with Aron Alpha.

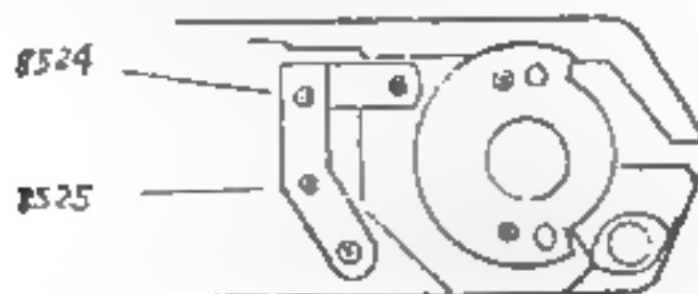
Use the shutter tester 7F7L1 and/or 7F7L3. The speed should be 11.7~12.1 ms. at 1/1000 sec.

Adjustments may be made by 8525 (Shaft) and 8524 (Shaft). Turn them to the right for stronger tension and faster speed, and to the left for weaker tension and slower speed. Care must be taken not to deform the driver groove at the upper end of 8525 and 8524, as it will cause poor operation of the curtains.

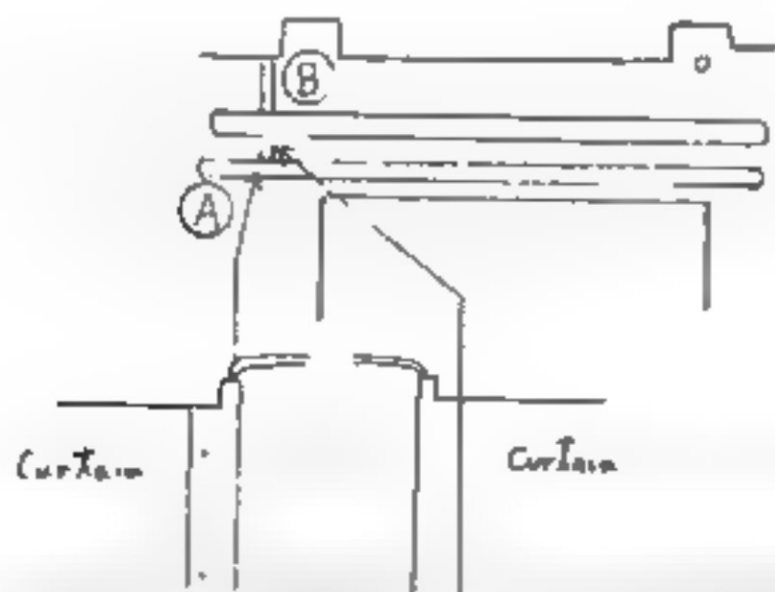
Tolerance: 0 - 0.3mm

- (4) Do not change the position of the Gear B but turn 8520 until the Patch of 8600 (Curtain) reaches closest to the Scratched line (A below) on the Die-cast Body. Then raise (8520) and let it engage onto the Gear B.

Make fine adjustment on the alignment of the Patch of 8600 and the Scratched-Line on the die-cast by adjusting the 5 holes' positions.

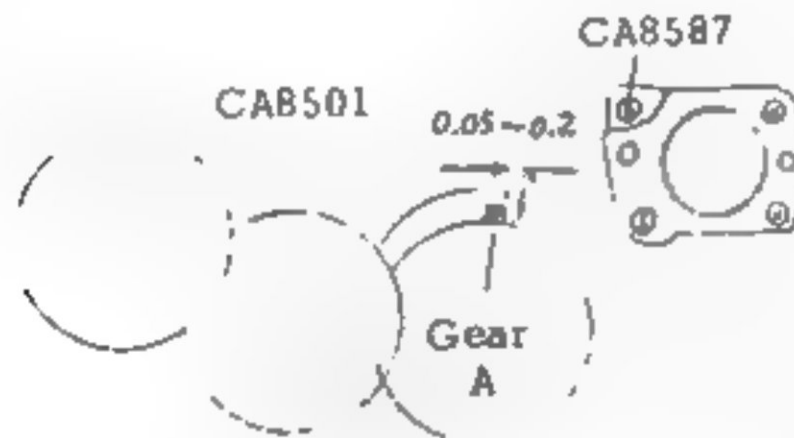
3) Brake adjustment unsatisfactory.

Upon adjustment of the curtain speed, when the shutter is released at 1/1000 or B, there should be a room of 0.05 - 0.2mm between 8501 (Base Plate) and the Gear A. If not, it should be adjusted to be within that range by 8587 (Screw). (It will change the spring tension of 8586 (Spring).)

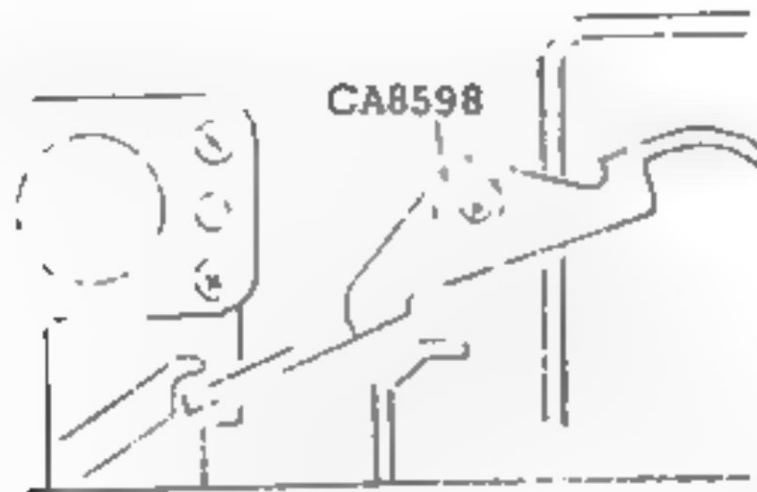
- 7) CA8595 (Lever) and CA8592 (Claw) stuck together.

8598 (Washer) is to be mounted in the manner shown below.

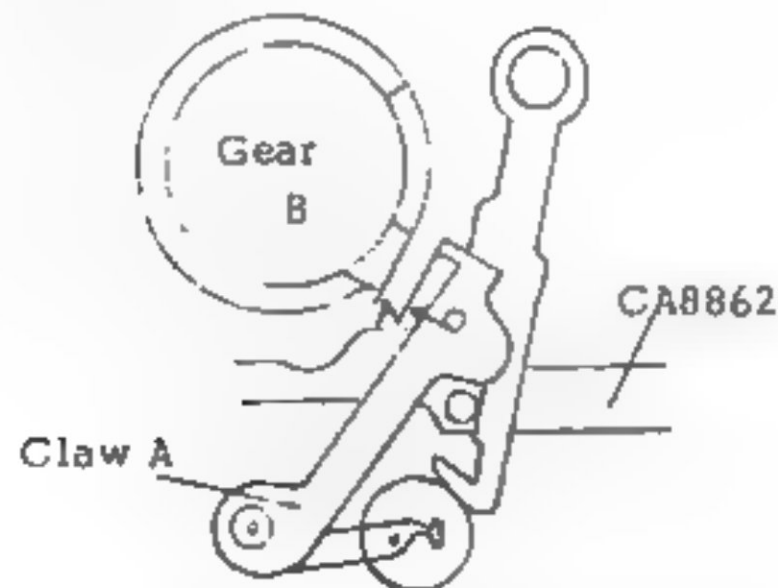
3. Adjustment of "B" shutter speed (Irregularity of B stop, immediate closing or remaining open)

- (1) Upon completion of shutter charging, 8862 (Plate) should return to the original position accurately. At this time there should be a space between Claw A of 8567 (Shaft) and the Gear B of 0.5mm or above. (See below, the portion marked A) If there is not, an adjustment must be made by bending the portion marked with a circle in the picture below.

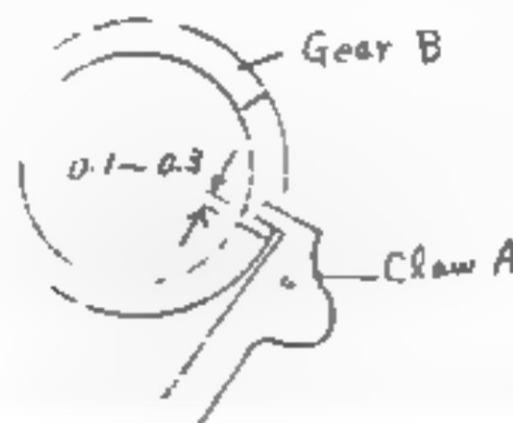
- 2) The space between Claw A and the Gear B.

Depending on the size of Claw A, there are three types of 8567 (Shaft). A proper selection should be made out of the three shown below, so that the space between Claw A and the Gear B would be 0.1 - 0.3 (as shown below).

An adjustment may be made by bending the tip of Claw A.

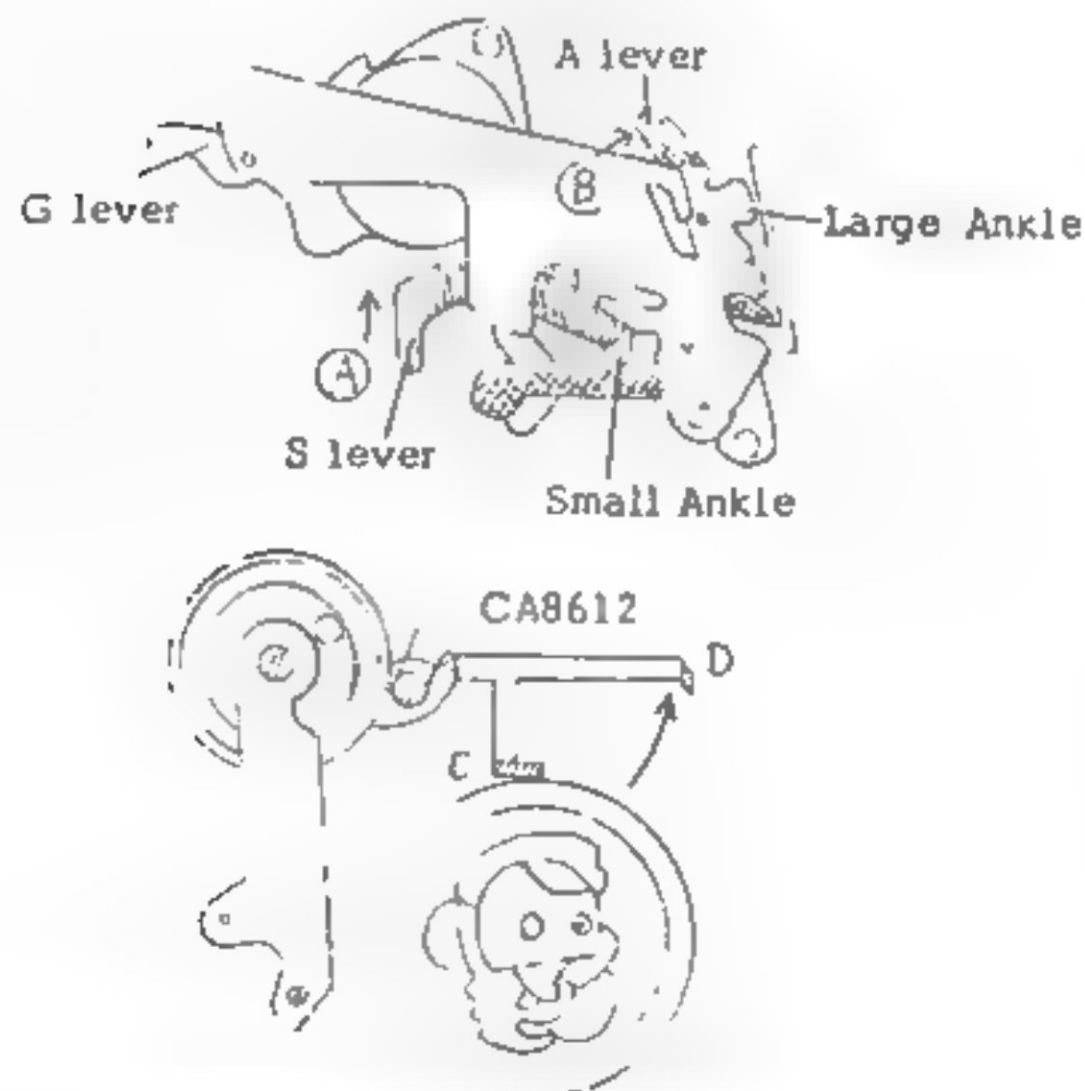
With 8575 set at  $1/1 - 1/8$ , when the Governor is worked upon completion of film advancement, the Ankle should not be engaged.

Adjust by bending portions C and D of 8612 like that relative parts work as follows.

When 8575 is set at  $1/1 - 1/8$ , immediately prior to the shutter charging action 8612 starts working and portions A and B of the governor should move in the directions indicated by arrows to release the Large Ankle and Small Ankle of the governor.

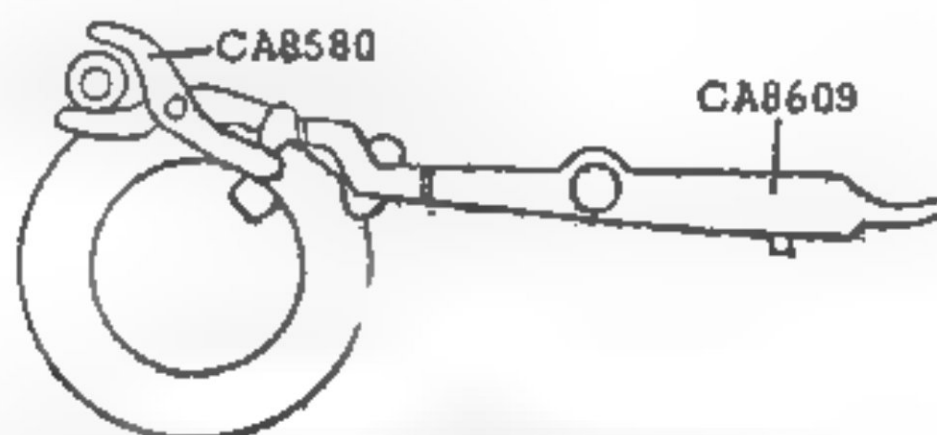
## 2) CA8580 lever rattling

Prior to film advancement, check the engagement between 8580 and 8609 by shaking vertically 8609. If such engagement is for less than  $2/3$  the thickness of 8609, adjust the room at the rivet of 8580 to be within 0.3.

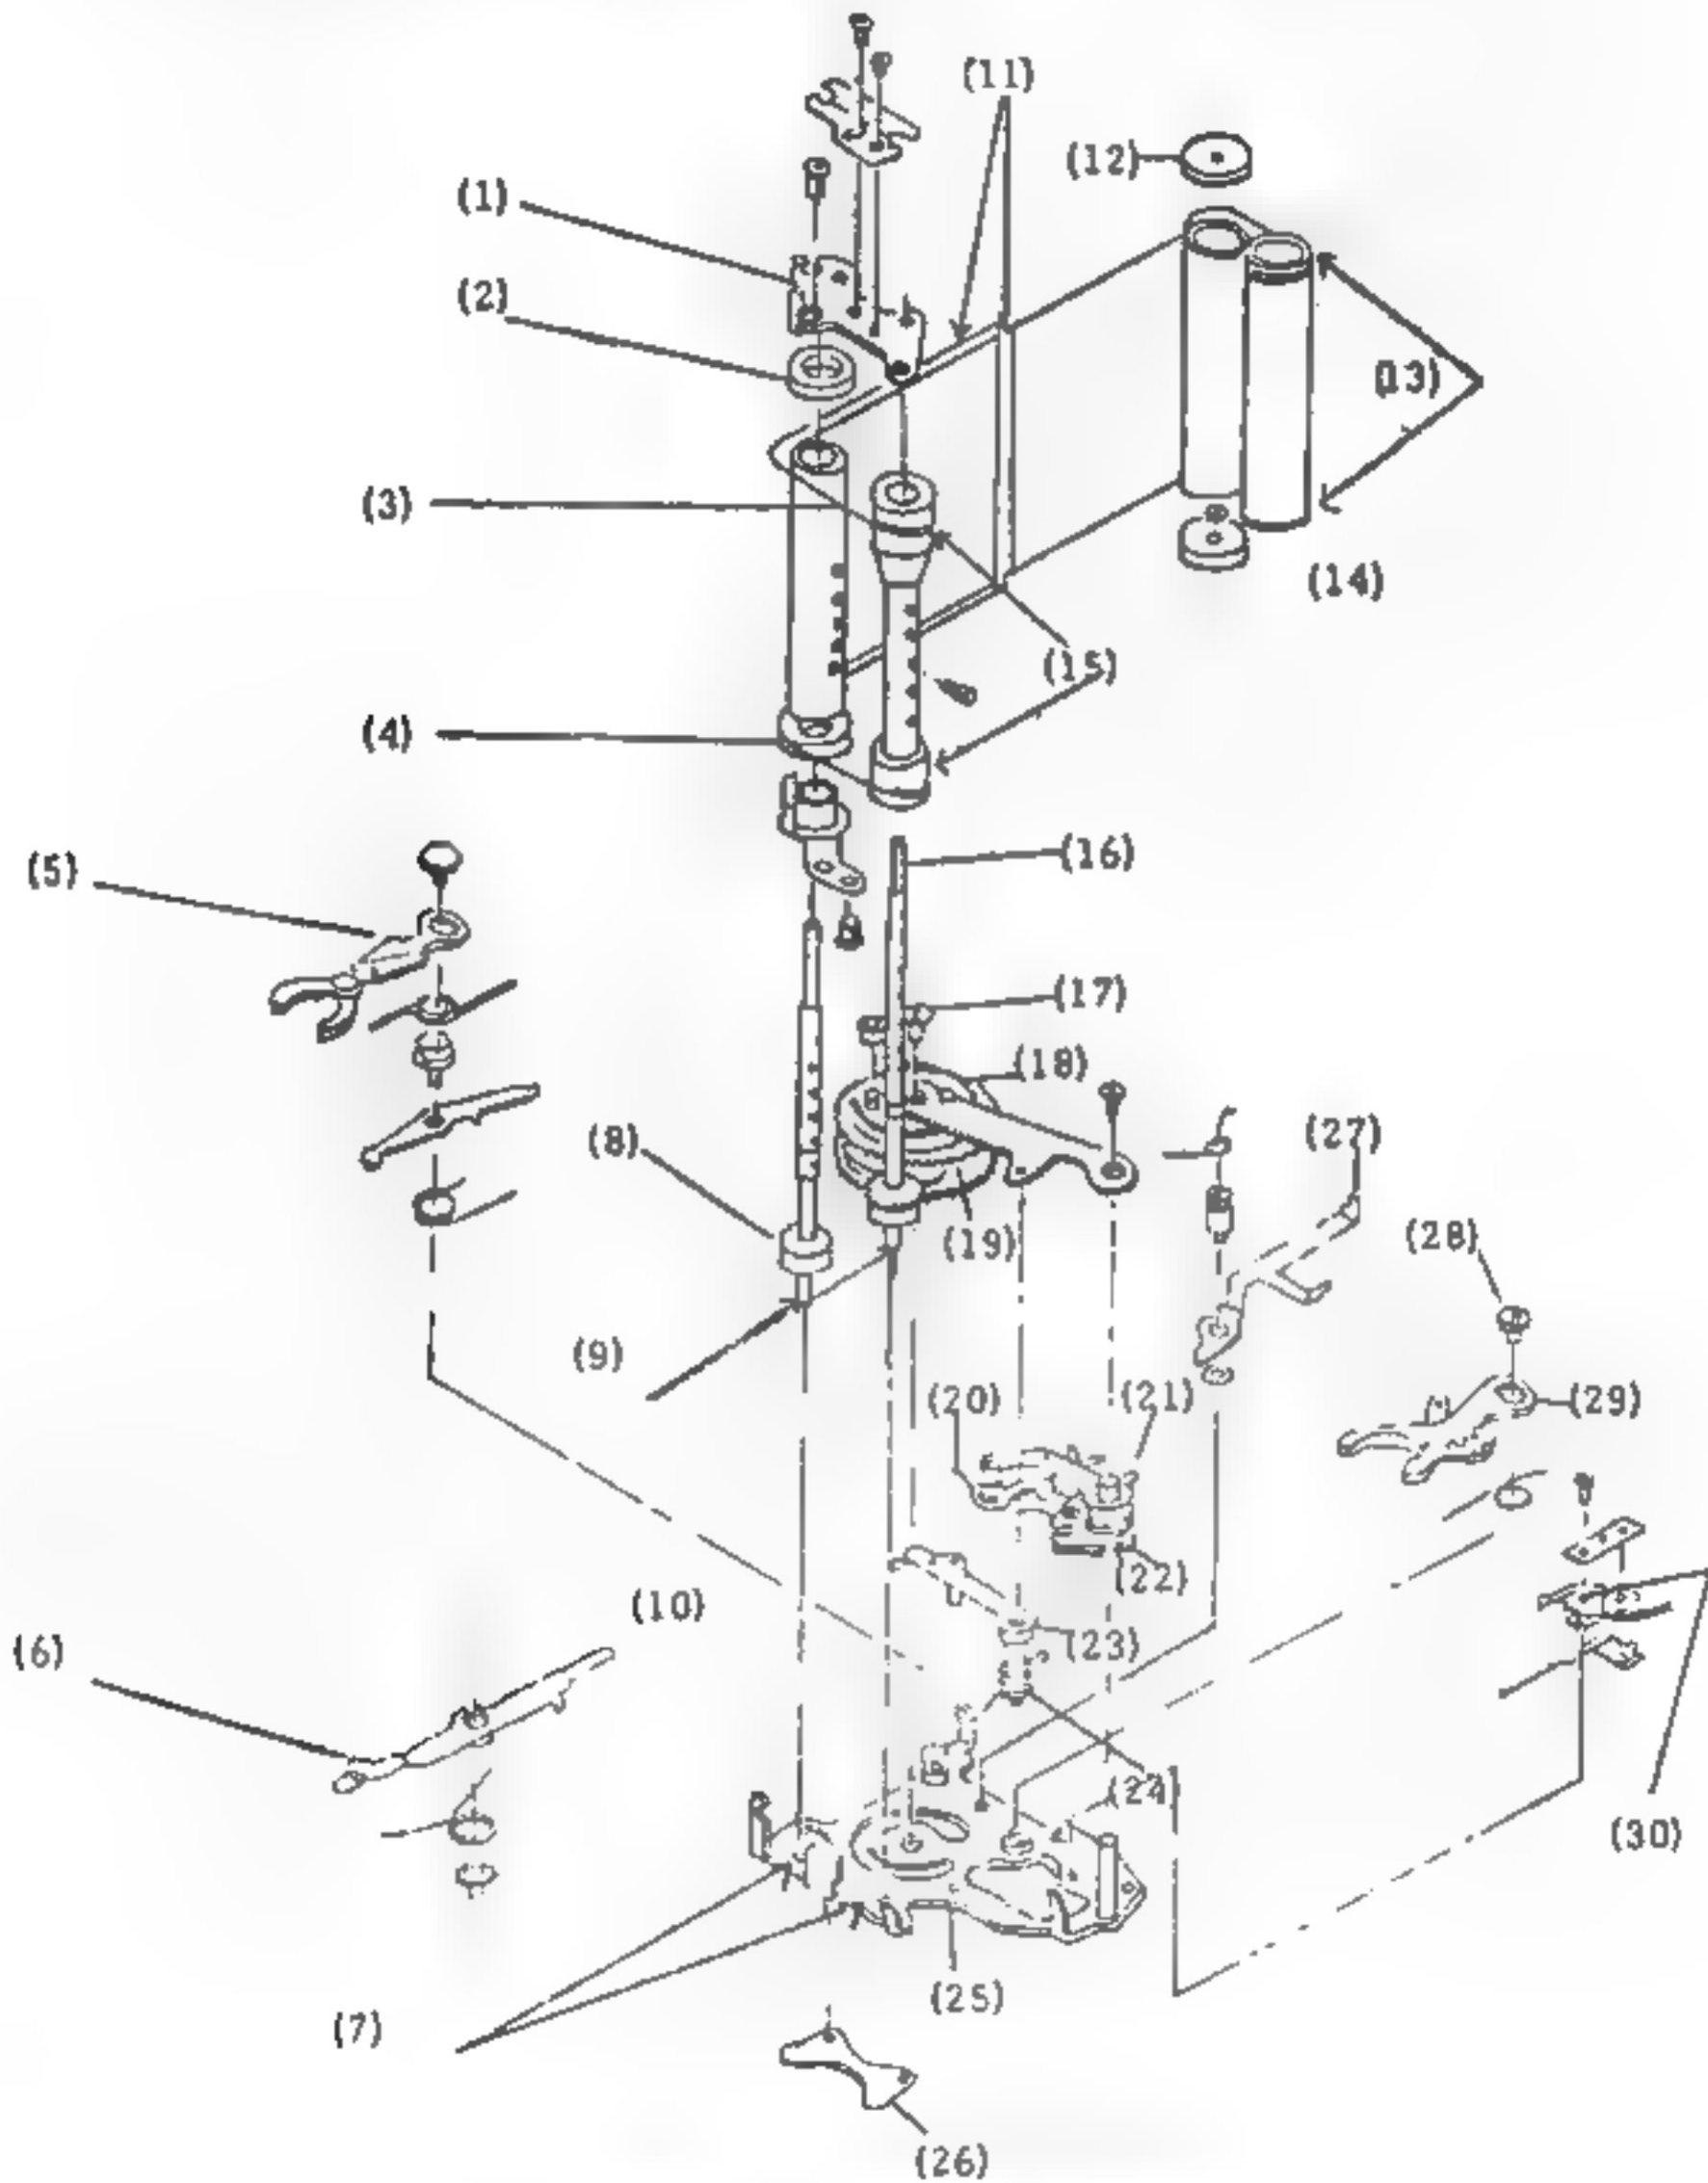
# 8. Irregularity in Curtain Speeds:

- (1) Mounting position of 8508.
- (2) Rotation of 8510. However, do not lubricate.
- (3) Whether 8537 (4 pieces) are off the roller.
- (4) Rotation of 8510. However, do not lubricate.

- (5) 8580. Check whether it with the Ring of the Shaft B.
- (6) 8609. Whether it is properly engaged on the lever.
- (7) 8501. Dirt or inaccuracy in surface finish at the guide holes for the Shaft A and B.

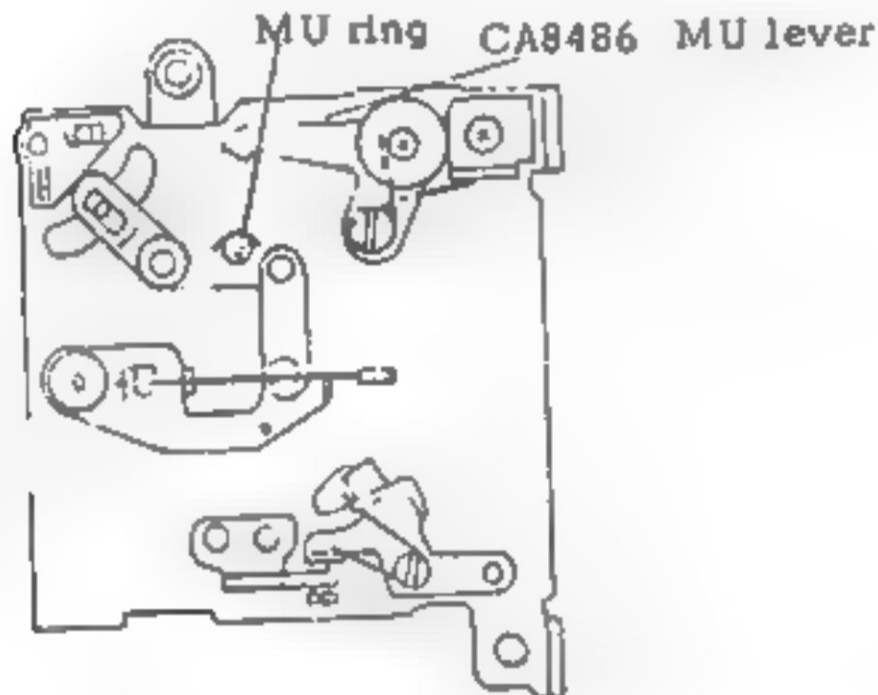
1) Improper selection of the MU ring

- (1) While the mirror is at the original lowered position, there should be a space of 0.2 or above between the tip of 8486 and the MU ring.
- (2) During the mirror-up operation, the mirror should be in such a position that its tip touches the damper and presses it accurately.
- (3) The MU knob should operate smoothly and should not get heavy toward the end of its motion.

Make a proper selection of the MU ring to satisfy the requirement cited in the Checkup column below.

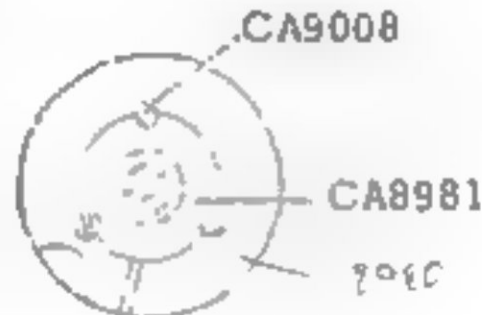
If the zero point is extremely out of position, adjust the position of 8981.

- (1) In case of + (an excessive swing), loosen 9008 and turn 8981 to the right.
- (2) In case of - (an insufficient swing), turn it to the left. Upon adjustment, turn the shutter dial to adjust the loosened string.

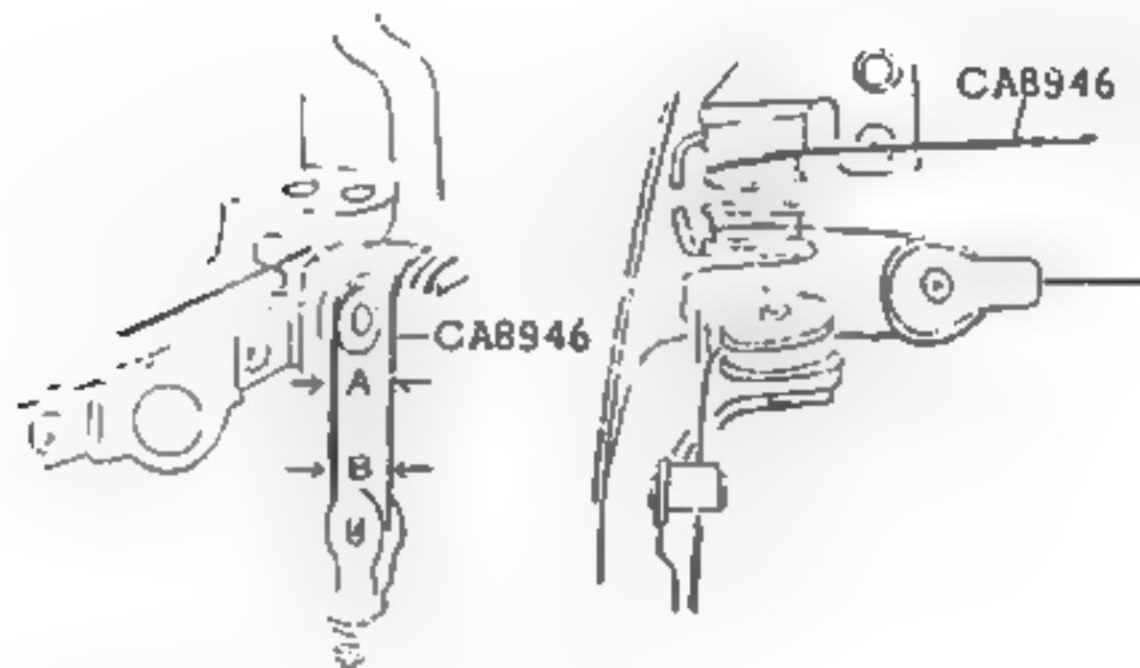
2) Adjustment of CA8946 (String) (dislocation and entanglement)

- o The string should not be dislocated from the pulley.
- o The width at A and B should be approximately the same.
- o When 8879 is turned until it hits the Cam Roller, there should be a space of less 1 mm between pulleys of the B spring and the B spring plate.

8946 is to be threaded as follows:

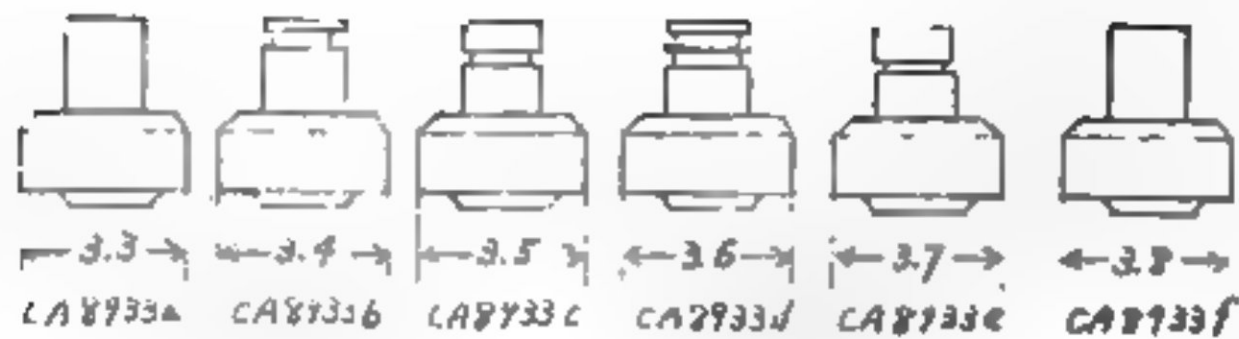
3) Improper selection of CA8933 (Roller) (diameter)

8933 should turn smoothly and accurately without an extreme difficulty such as stoppage and uneven movement.

Referring to the checkup column on the right, make a proper selection and check the operation.

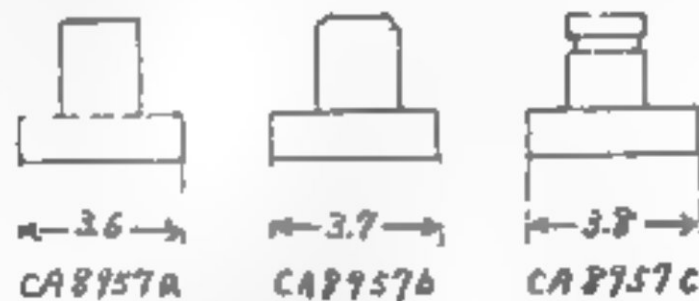
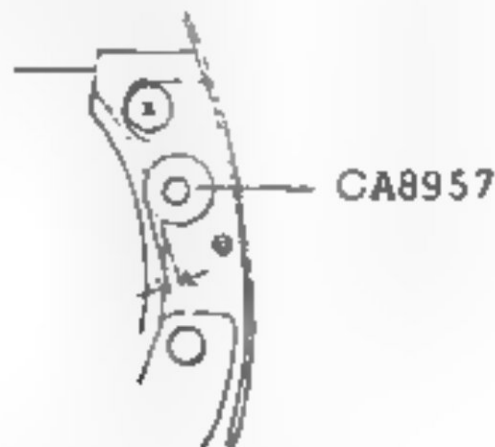
#### 4) Improper diameter of CA8957 (Roller)

A little space may be permissible between 8957 and 8879. (If the roller selection is made allowing no space between them, it sometimes causes poor returns of 8879.)

8957 comes in three types. Referring to the checkup column make a proper selection and check the operation.

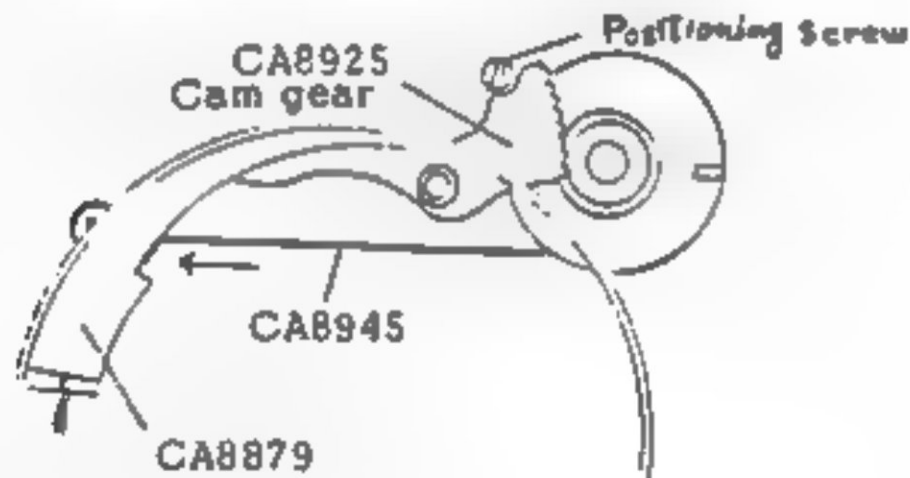
- o Upon adjustment, there should be a space between the A and the stopper pulley.
- o When 8879 is turned to its fullest extent, the A should not hit 8925.

When 8945 is pulled fully toward the arrowed direction, the space between 8879 and 8925 should be with 0.3mm. An adjustment should be made to fulfill this requirement by the Positioning screw.

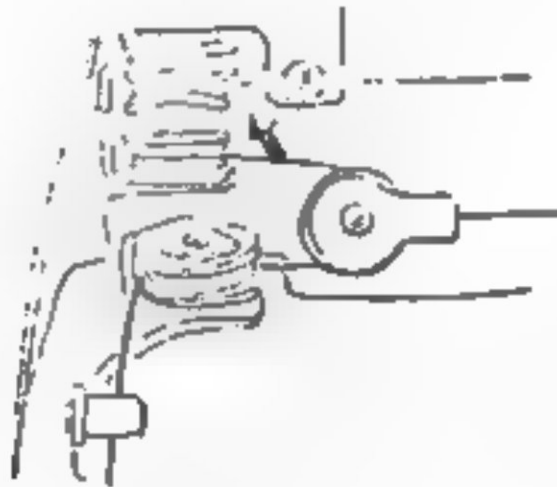
- o If the meter is not mounted onto the Front Die-Casting, attach a 12 gr. weight at the tip of the string and check the operation.
- o Each pulley is to turn smoothly and accurately.
- o Tolerance on the dial gear should be 0.1 or less.
- o When the dial gear is rotates, 8924 should not move.

8944 (the string for the dial gear) should be threaded as follows. When threading, it should be started from the arrowed direction to avoid crossing with the String.

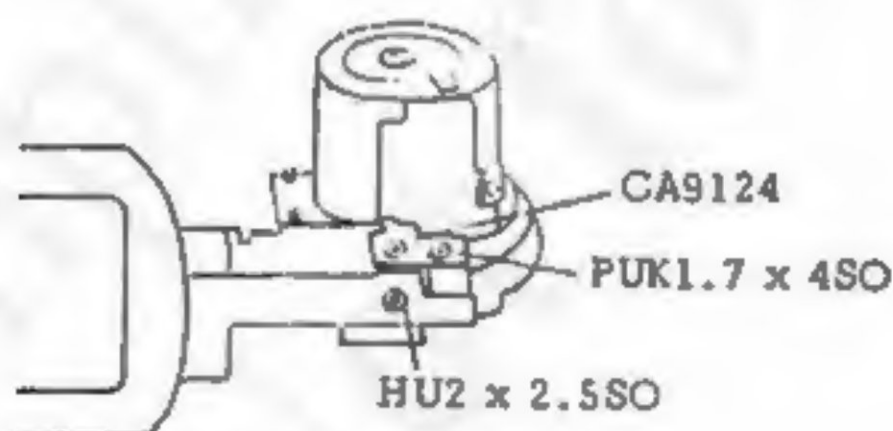
- o Place the mercury battery in the camera and turn off the main switch.
- o With ASA 100 at the shutter speed B, the aperture ring is gradually turned from F16 toward open. At this time, the meter needle should once jump to + 2.0EV above the index center before it stays at - 0.5EV. (See Fig. A)

Ref. Checkup column. Loosen two PUK1.7 x 4SO on 9124. Slightly move HU2 x 2.5SO forward or backward for adjustment.
